# Losing Control

By *Quintin Cairncross*

At 1100 universal coordinated time (UCT) on 31 December 2013 a Cessna 525A Citation CJ2+ is flying from Leeds Bradford Airport in the UK to Palma de Majorca in Spain. Seated in the cabin is one female passenger. The occupants are no doubt looking forward to spending New Year's Eve in the somewhat warmer climate of their Mediterranean island destination.

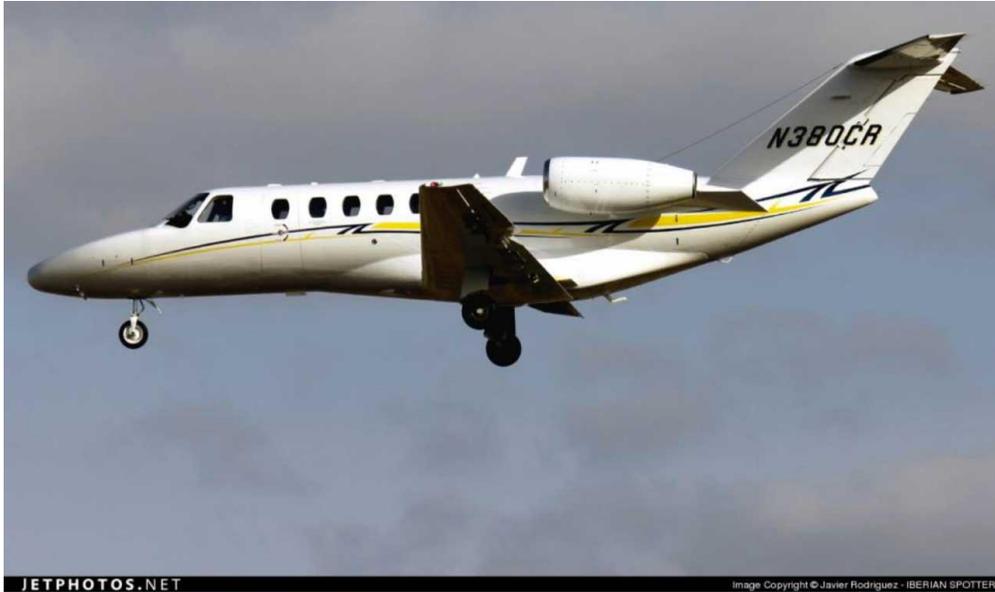
The accident aircraft N380CR (Credit: Jetphotos.net Javier Rodriguez - Iberian Spotters)

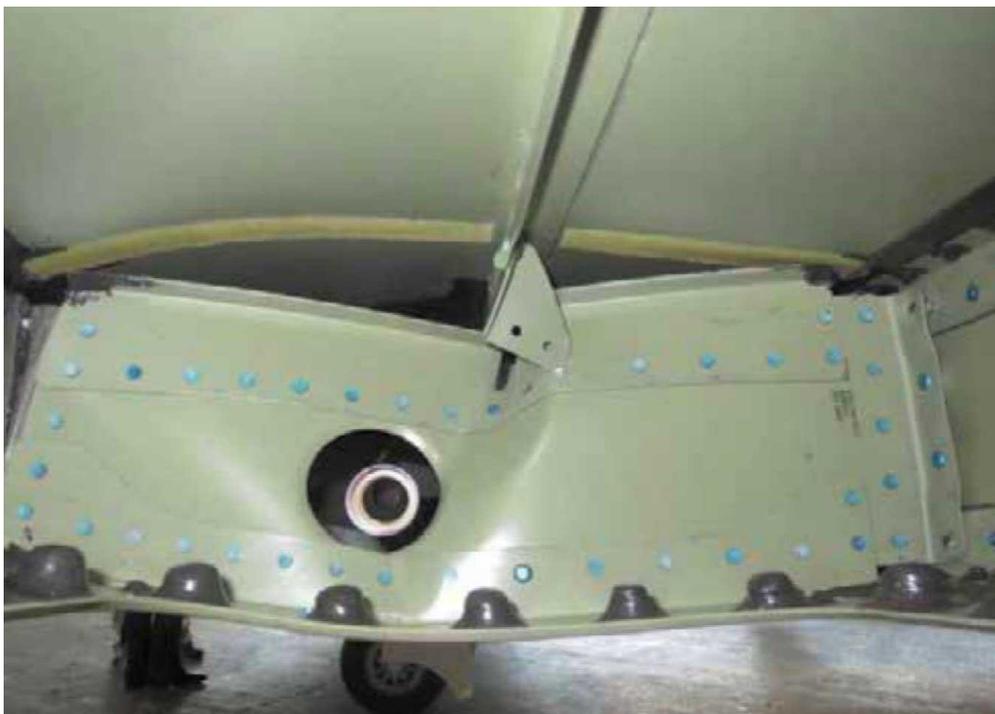
Inspection after the accident flight reveals that the aircraft wings have been damaged in overload. Five ribs in the outboard wingbox are damaged by buckling and the bonded joints between the ribs and the upper and lower wing skins have failed. The upper and lower wing skins are permanently deformed with significant loss of aerofoil shape. The Cessna wings contain integral fuel tanks. Fortunately, this part of the structure has maintained its integrity and there were no fuel leaks, with the wing skins remaining attached to the front and rear wing spars. There is also wing skin buckling above the main wheel wells close to the fuselage. The damage is consistent with symmetrical 'pullout' loads between +3.6g (limit load) and +5.4g (ultimate load). Both Ailerons show evidence of skin wrinkling along the trailing edge of the upper and lower surfaces.

## Right Wing rib damage at approximately mid-span of the aileron (Credit: UK AAIB)
