## CJP Issues our First Safety Bulletin

*Heads-up on Baro-VNAV, a primer on the upcoming Safe to Land(sm) course, and a Textron Aviation accident review*

### **CJP Safety and Education Foundation Safety Bulletin: Baro-VNAV Approaches and QNH settings**

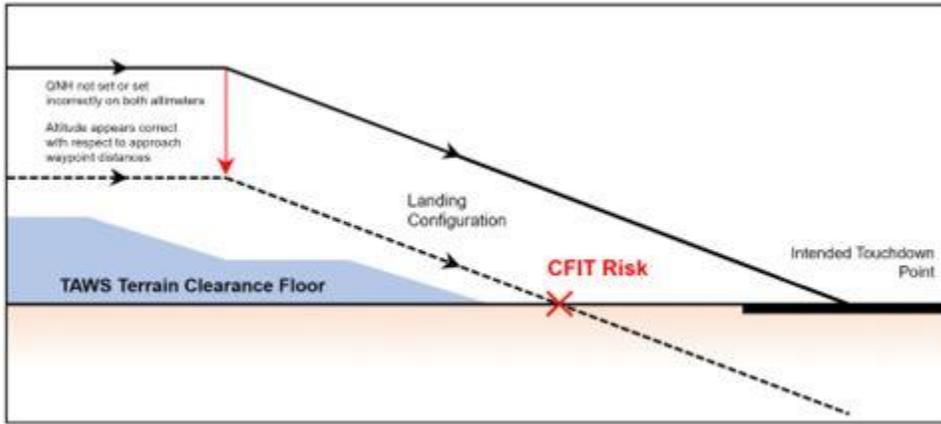
An under-appreciated threat of baro-VNAV guidance on final approach is that an incorrect altimeter setting will result in a centered vertical deviation indication (VDI) when the aircraft is actually low or high. Contrasted with an ILS (vertical guidance from a ground-based signal) or a WAAS approach (vertical guidance from augmented GPS position), a baro-VNAV approach creates the opportunity for a single point of failure in the form of a mis-set altimeter.

Diagram in 2019 UK CAA safety notice of threat of mis-set altimeter during baro-VNAV approach

As the correct altimeter setting is of crucial importance during a baro-VNAV approach, the CJP Safety and Education Foundation strongly recommends members adopt the following SOPs:

- When flying an approach with baro-VNAV guidance on final, the pilot should obtain and cross-check a minimum of two independent altimeter settings. Possible sources include:
  - o ATIS/ AWOS/ ASOS
  - o ATC
  - o METAR received via SXM, ADS-B in, or datalink
- Approaching minimums the pilot should check the radar altitude (if equipped), against the charted height above TDZ at minimums. Understand that variations in terrain and buildings can cause a difference in displayed RA.
  - o If the aircraft has the ability to set two different minimums alerts (e.g. ProLine 21), consider setting one alert to radar height above TDZ and one to baro minimums.

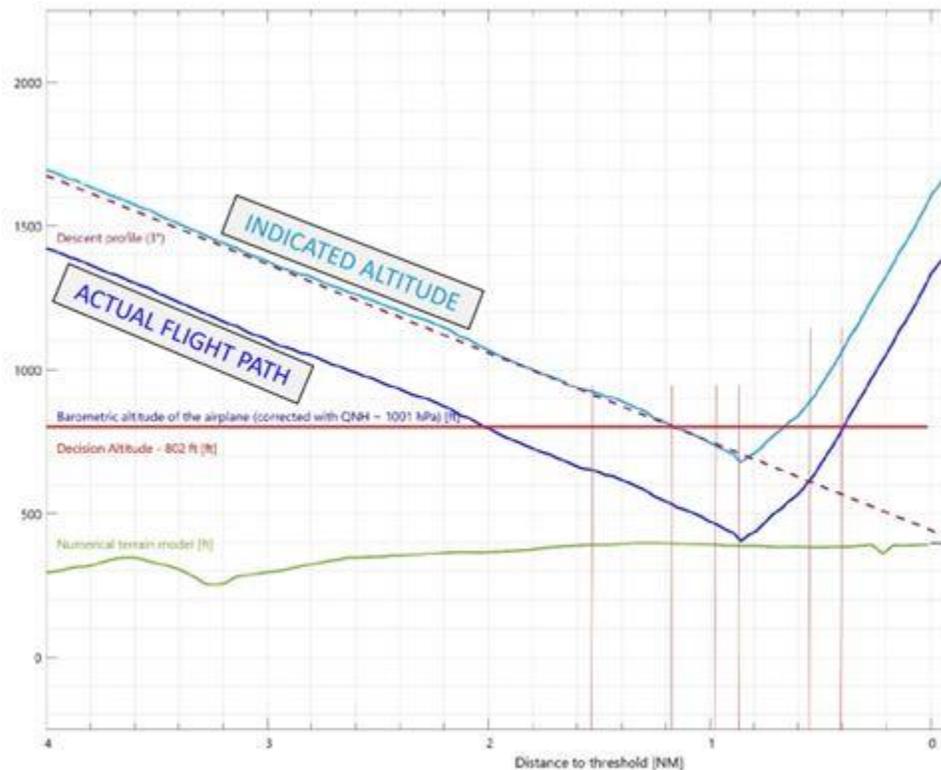
In May of 2022, an Airbus A320 with 178 passengers and crew aboard came within six feet of the surface while nearly a mile from the runway threshold of runway 27R at Paris' Charles de Gaulle (LFPG) airport. The aircraft had received an incorrect altimeter setting from the approach controller, and as a result was flying 280 feet lower than indicated altitude throughout the final segment of the approach.

Flight path of NSZ 4311 vs. indicated altitude and desired path

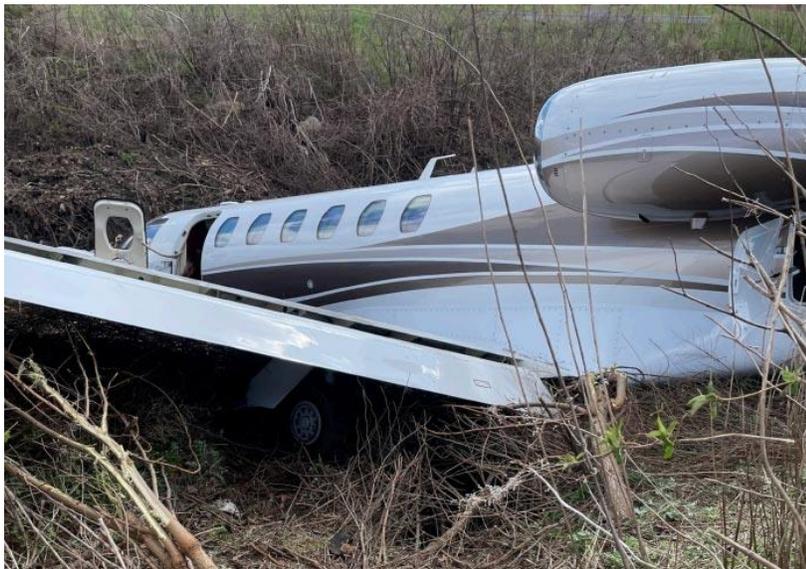
*NTSB Photo (cropped) Docket ERA22LA190*

A CJ3+ overran the runway after touching down long at KCDW, Essex County Airport in Caldwell, NJ in April of this year. [The NTSB final report is out on N225SC](#), operated by a crew into the airport, which has a 4,400-foot-long runway. Peter Basile of Textron will do a deep dive of this interesting scenario at our convention in Austin next month, but here's a teaser that relates directly to our STL course and the concept of the Touchdown Point Limit, or TPL.

On the day of landing, the weather had changing-direction, strong, gusty winds. The reconstructed data at time of landing showed dry runway, winds 290/13, runway 22, landing weight 10,100 pounds. OAT 11 deg C, altimeter 30.14. The calculated Vref was 97 and the landing distance (unfactored) was computed to be 2,400 feet. If you add a 25% safety factor (the minimum we recommend per CJP SOP) the landing distance required would be 2,400 x 1.25, or 3,000 feet.

In other words, a test pilot could achieve 2,400 but our expected best performance would be 3,000 feet in these conditions. Interestingly, with a 4,400-foot-long runway, TPL is only 2,400 feet down the runway; in other words, any touchdown beyond 2,400 feet down the runway is nearly certain to go off the runway.

Surveillance cameras showed the aircraft touched down 3/4ths the way down the runway, or 3,300 feet from the approach end. No one should ever land on a runway and then wonder if they have enough runway to stop!

If you are not yet familiar with the TPL concept, not to worry, we will cover it in detail in the STL ground school at the convention. If this crew at KCDW knew they were in trouble for any touchdown beyond 2,400 feet, they would almost certainly have initiated a go-around.

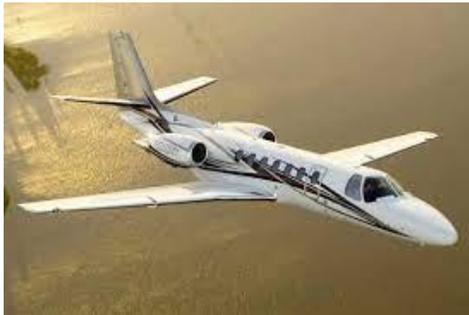
On January 11, 2017, a C560 Encore took off from Runway 19L at Oslo Airport Gardermoen (ENGM), Oslo, Norway. After passing through 2,000' MSL the crew retracted the flaps and the aircraft's nose dropped to a pitch attitude of -33°; the pilots later reported they were "hanging by their seat belts."

Onsite technical assistance was provided by Textron Aviation during an examination of the aircraft and its systems, no pre-event malfunctions were found. During the examination, multiple instances of structural damage were noted to the aircraft including: creases on the upper surfaces of both stub wings and contour deviations on the left and right sides of the fuselage near the engine nacelles. No system abnormalities were noted.

The investigation determined, through the use of CVR data, that the anti-ice and de-ice systems had been activated by the crew before the event. The investigation could not determine if the flap retraction played a role in the upset. The AIBN concluded that the upset was caused by the tailplane stalling due to accumulation of slush and snow while on the ground due to a lack of deicing on the ground. This included slush spray from the tires during taxi and takeoff.

Flight crews need to factor in the possibility of their planned taxi route changing or an extended time until takeoff when making decisions about ground deicing. It is also important to not allow continuation bias to drive a decision to continue to takeoff when the safest decision is to taxi back for deicing.
