## CJP Issues our First Safety Bulletin

*Heads-up on Baro-VNAV, a primer on the upcoming Safe to Land(sm) course, and a Textron Aviation accident review*

### **CJP Safety and Education Foundation Safety Bulletin: Baro-VNAV Approaches and QNH settings**

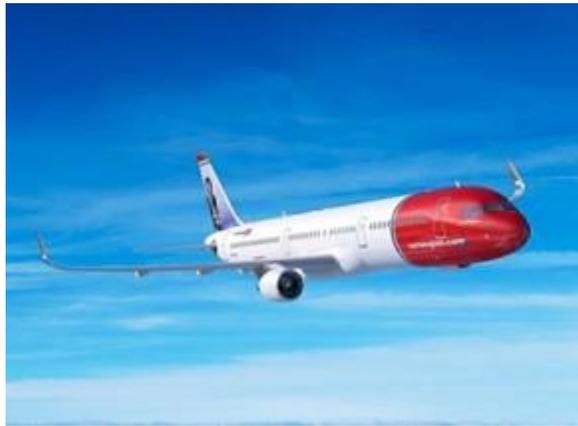
In May of 2022, an Airbus A320 with 178 passengers and crew aboard came within six feet of the surface while nearly a mile from the runway threshold of runway 27R at Paris' Charles de Gaulle (LFPG) airport. The aircraft had received an incorrect altimeter setting from the approach controller, and as a result was flying 280 feet lower than indicated altitude throughout the final segment of the approach.

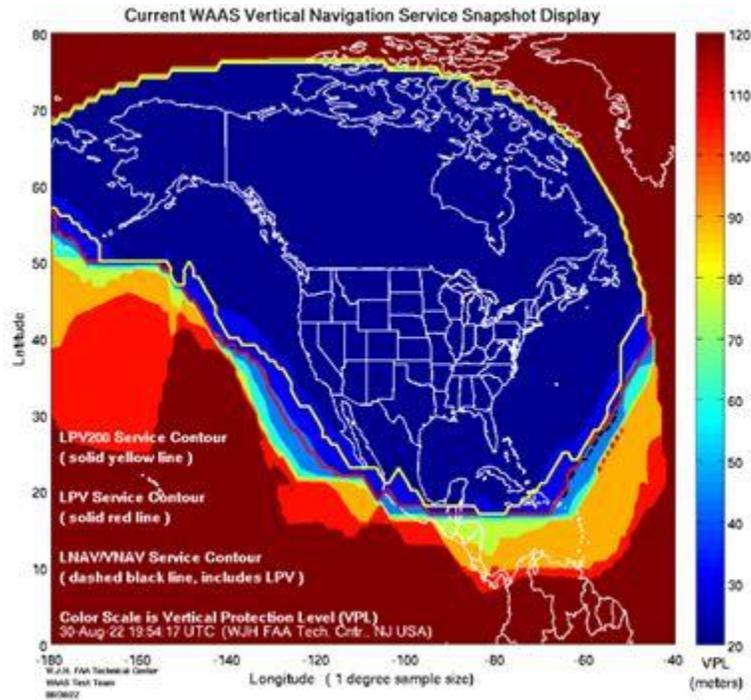
The red outline above shows the real-time limit of the WAAS service for LPV or LNAV/ VNAV minimums. Outside that area baro-VNAV would be needed for vertical guidance during an RNAV approach.
